**NBSIR 74-449**

# **Fire Endurance Tests on Walls and Plumbing Chases Containing Either Metallic or Nonmetallic Drain Waste and Vent Systems**

November 1973

Interim Report

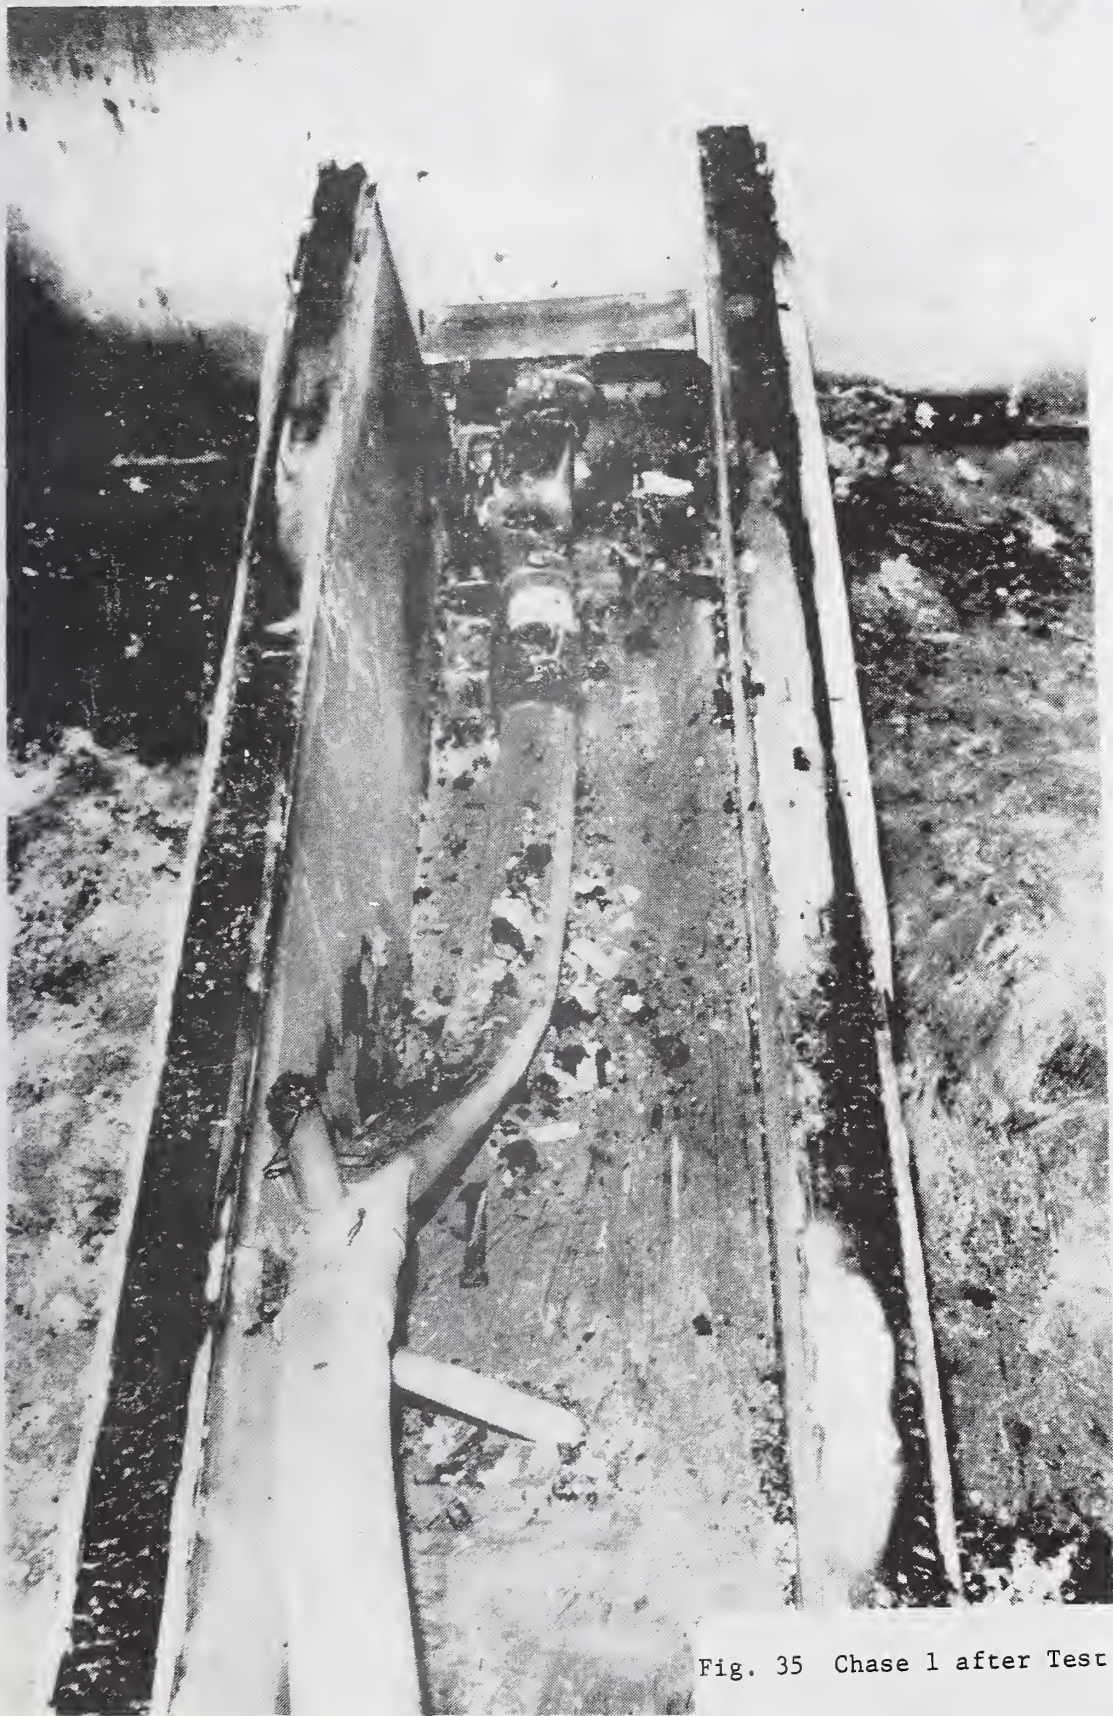
Fig. 35 Chase 1 after Test 1.

Chase 1 is shown after the test in figure 35. The collapse of the stack took place after the test was over. The charring of the stack was due to some debris which fell on it. The lateral leading to the furnace was burned off 5-1/2 inches from the tee at the point of attachment of the number 2 thermocouple. The burning of the lateral did not extend beyond the inside layer of gypsum board. The inside of the remaining lateral was partially closed off due to char formation leaving a 1 inch diameter passage through it. The damage inside chase 1 could be regarded as slight.

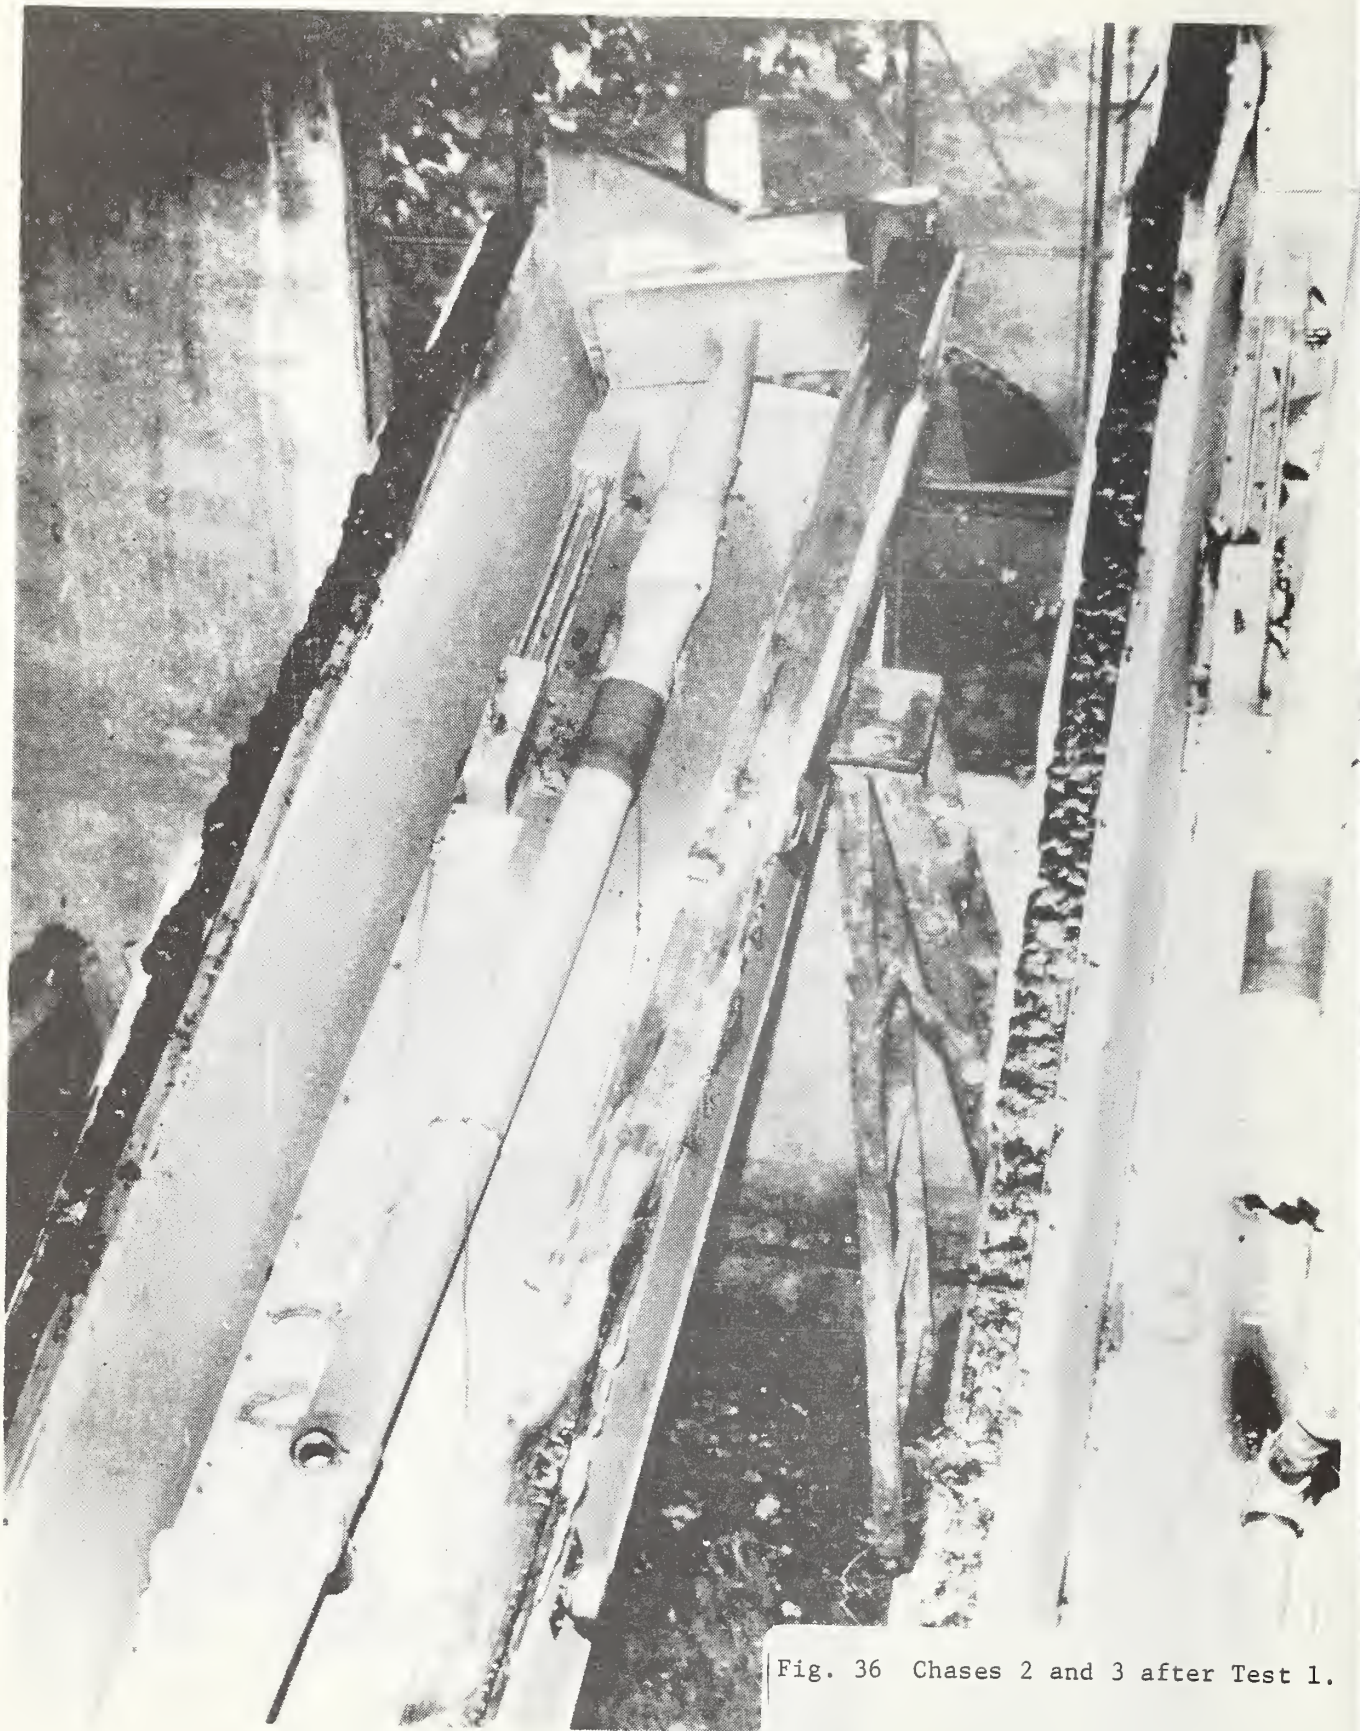
Fig. 36 Chases 2 and 3 after Test 1.

Figure 36 shows chases 2 and 3. In chase 2 the lateral burned a distance of about 2 inches into the sleeve and closed the remainder of the lateral off by char formation. The scorch on the stack just above the lower lateral in chase 3 is probably also due to the presence of hot debris which fell on it after the test. The damage in these two chases could also be regarded as slight.

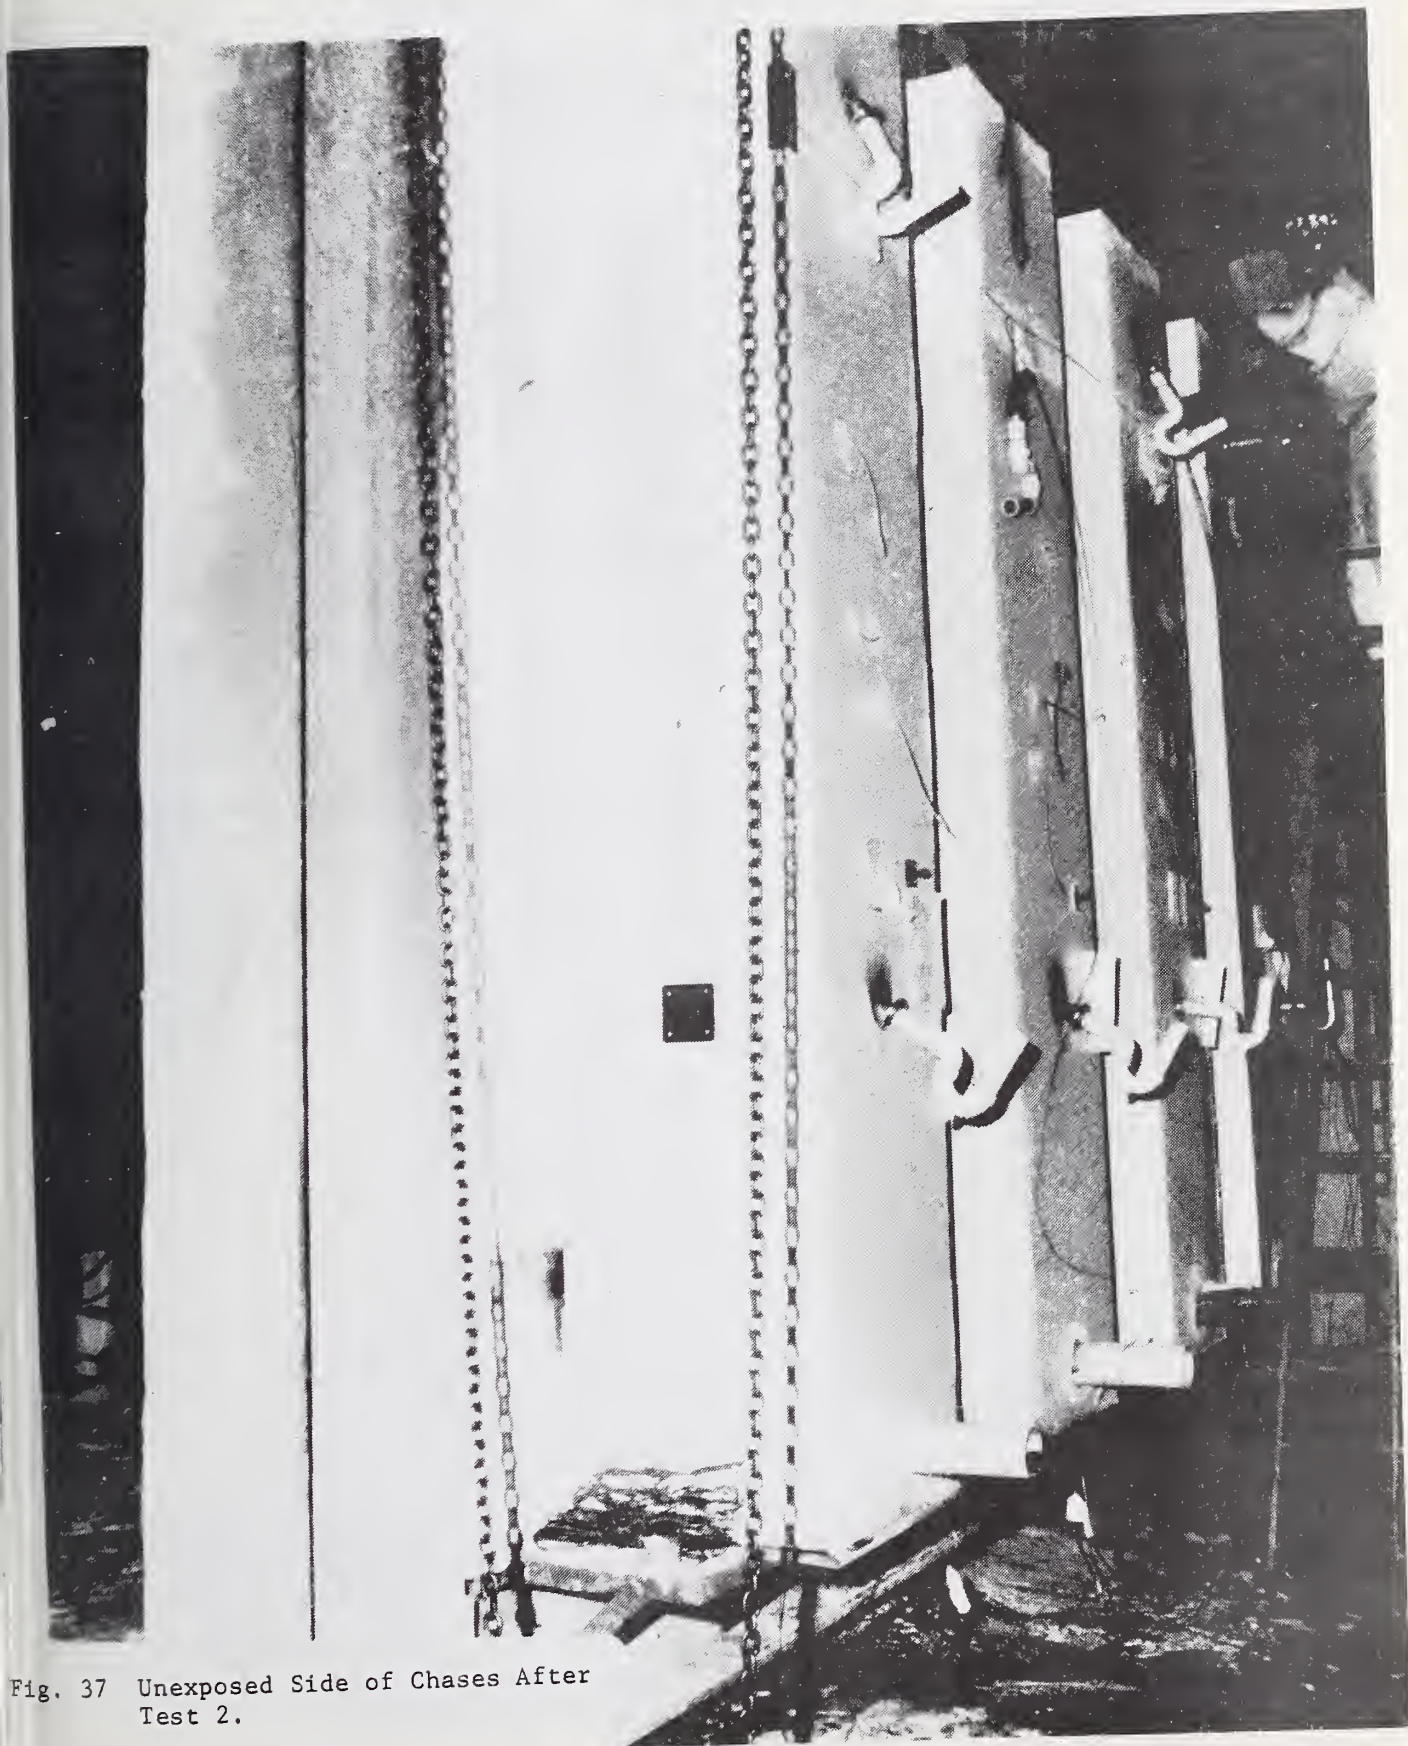
Fig. 37 Unexposed Side of Chases After Test 2.

The unexposed side of the chases can be seen in figure 37. The P-trap hanging down along the wall was removed from its lateral after the test. Although the P-traps sagged on the unexposed side of the chases (due to inadequate wire support), they remained in place and did

not pass flame or hot gases sufficient to ignite cotton pads during the test. The upper laterals pulled out of the stacks in chases 5, 6, and 7 and then sagged on the inside of the chases making it impossible for the P-traps to fall. The lower laterals on the unexposed side of the stack in chases 5 and 7 remained intact. In chase 6 the lower laterals remained in the sleeves attached to the walls. In chases 5 and 7 the laterals on the exposed side of the stack burned past the wall into the chase, pulled out of the reducing double sanitary tee and fell to the bottom of the chase. The stacks in chases 5 and 6 melted down into a mass about 4 feet long, and congealed around the thermocouple wires used to measure the temperature in the gas stream. The damage in chase 5 can be seen in figure 38. Although there was a considerable amount of charring of this mass there was no evidence of flaming. The hubless cast iron stacks in chases 7 and 8 remained in place and the neoprene gaskets in the clamps appeared to be in good condition after the test.

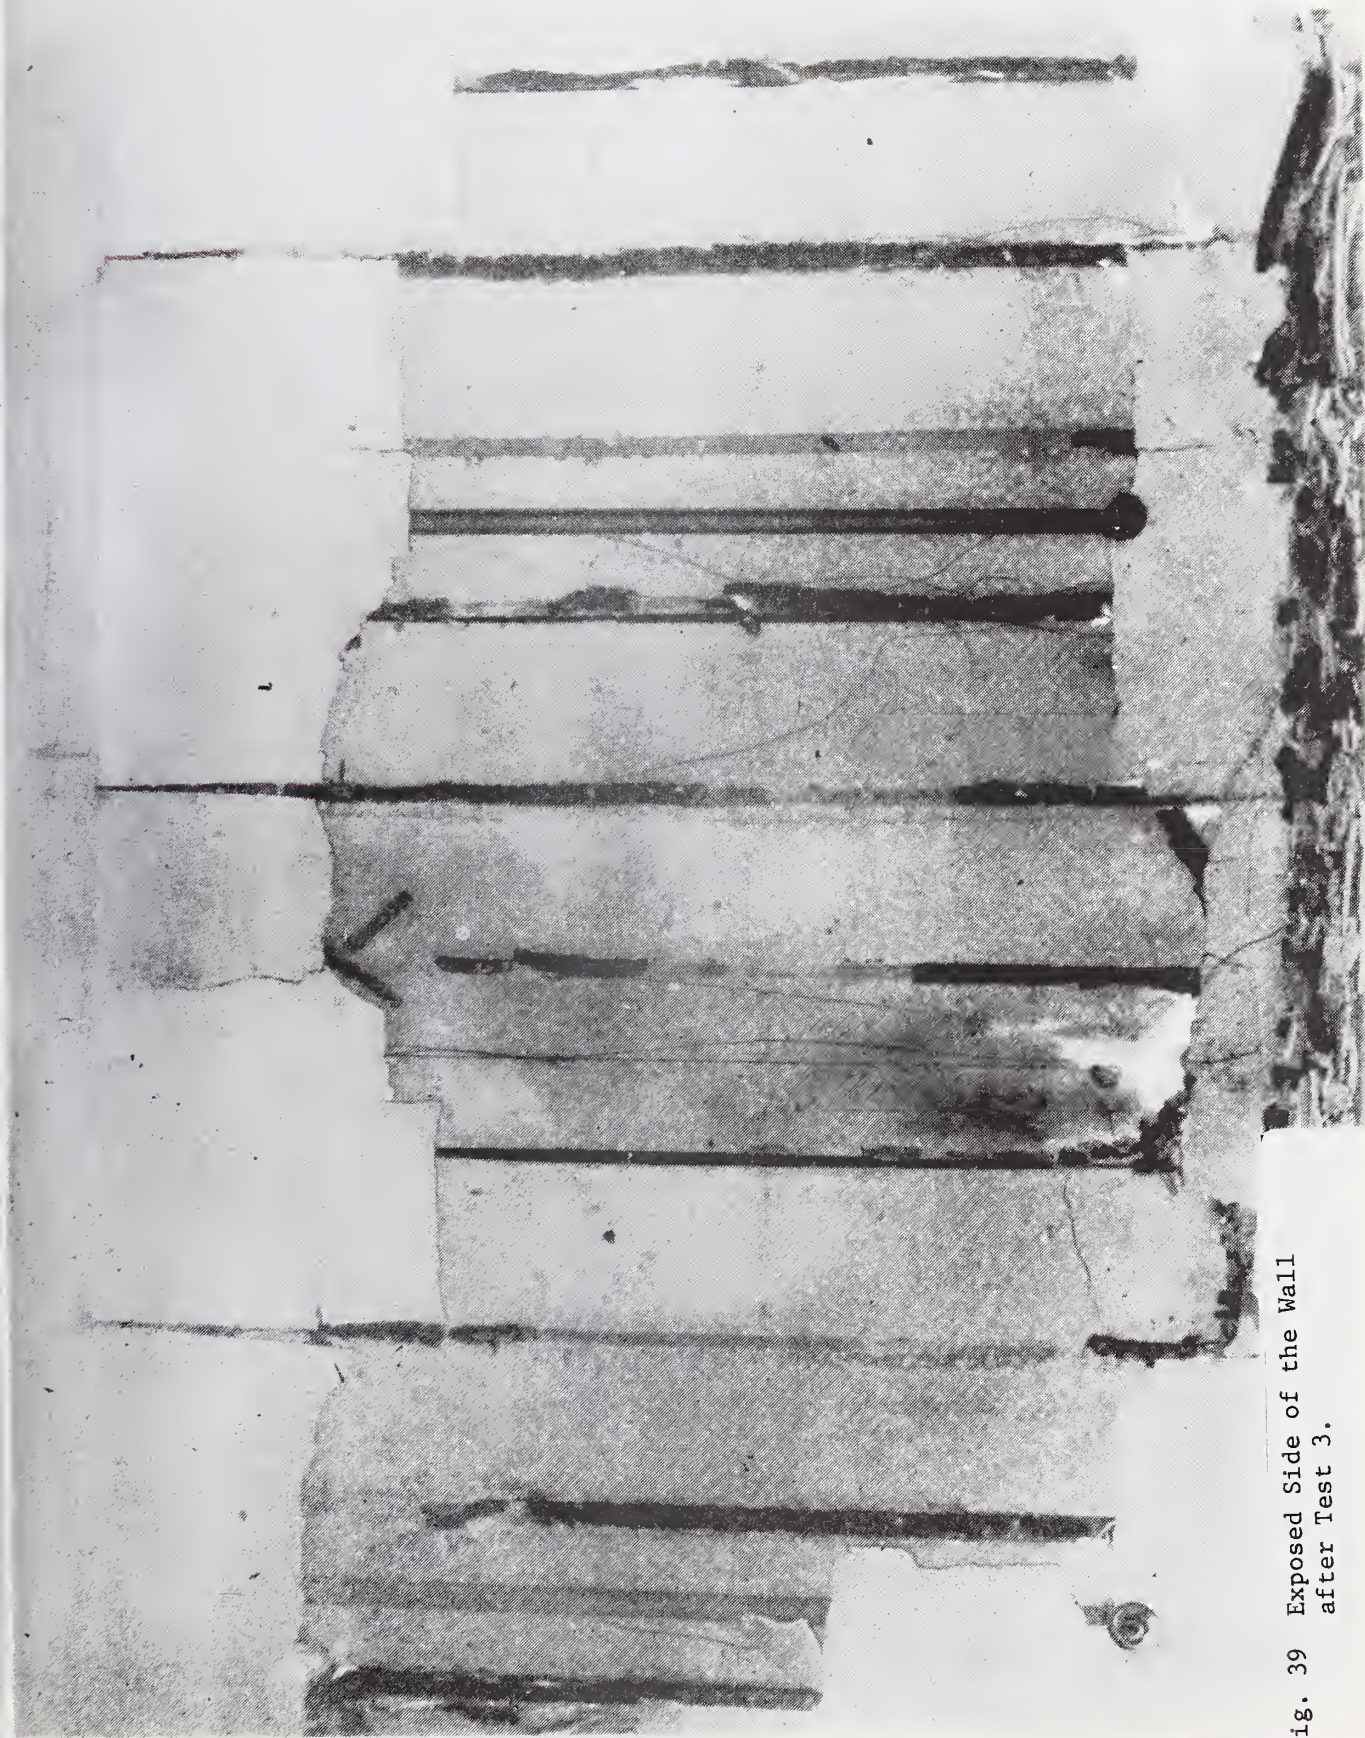
Fig. 39 Exposed Side of the Wall  
after Test 3.

The condition of the DWV installations after Test 3, which was stopped at 55 minutes, can be seen in figure 39. The copper and galvanized iron stacks were still standing. The ABS stack was completely consumed and the PVC stack had some fragments left which amounted to less than 10 percent of the original pipe. Figure 40 shows the lower PVC trap on the unexposed side of the wall about 15 minutes after the test was terminated. The paper on the gypsum board wall was charred by the penetration of high temperatures through the wall, yet the PVC P-trap remained undamaged.

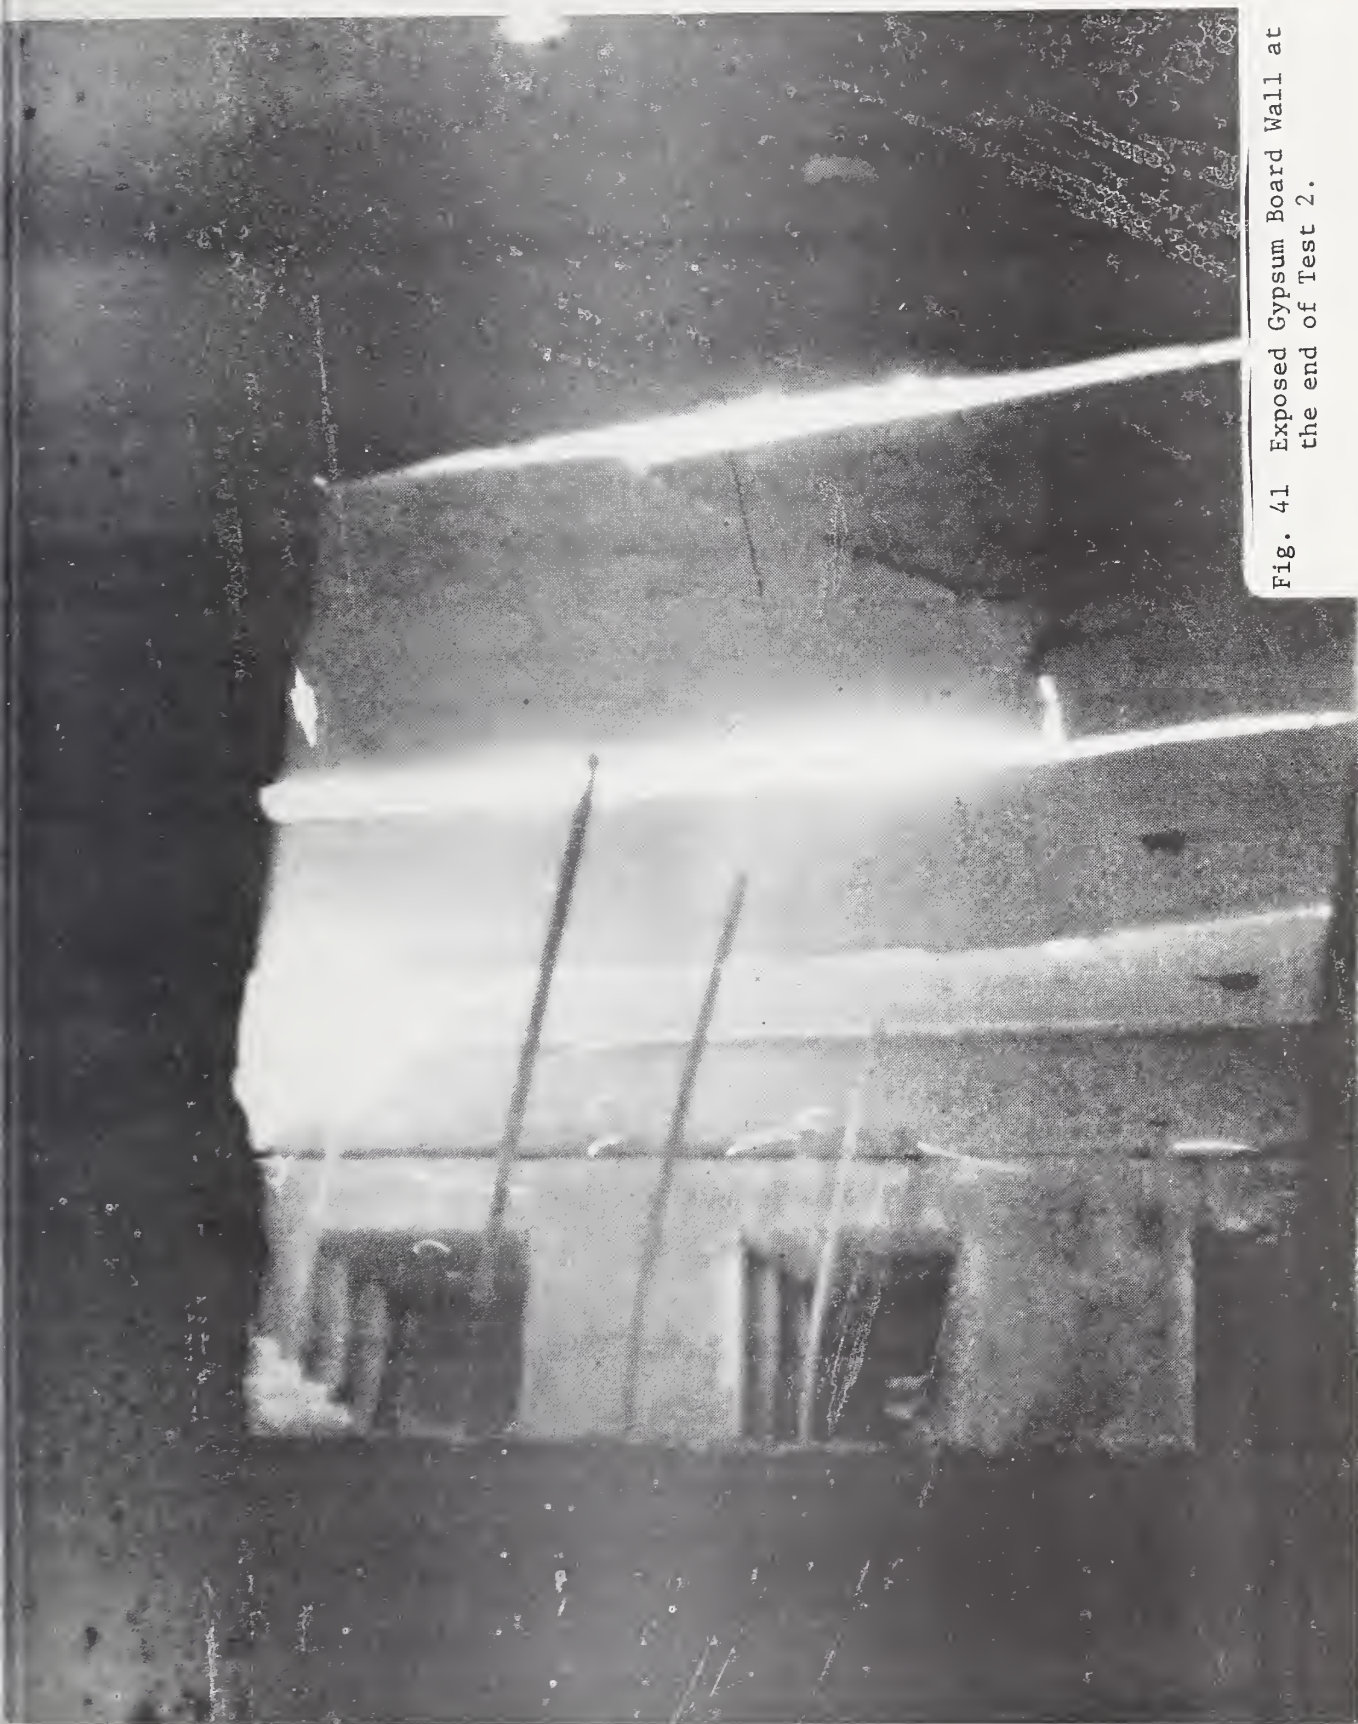
Fig. 41 Exposed Gypsum Board Wall at  
the end of Test 2.

The second test was stopped (gas off) at 50 minutes when the unexposed surface of the wall between chases 1 and 2 indicated a temperature of 483°C and was rising rapidly. Figure 41 shows the vertical crack in the third gypsum board panel which permitted a high heat transfer rate to the back wall. The reason why the crack developed as early as it did is not known. The test was stopped to examine the condition of the pipe at this time. Sprinklers which had been installed in the chase were turned on as soon as the gas supply to the furnace was turned off. The temperature rise of the unexposed surface of the walls between the other chases were well below 181°C at the time the test was terminated.
